New York State Department of Transportation

Yellow Flag NB22CTW026

BIN: 1065318

Gowanus Expressway
2022 Biennial Inspection - Field Sketch

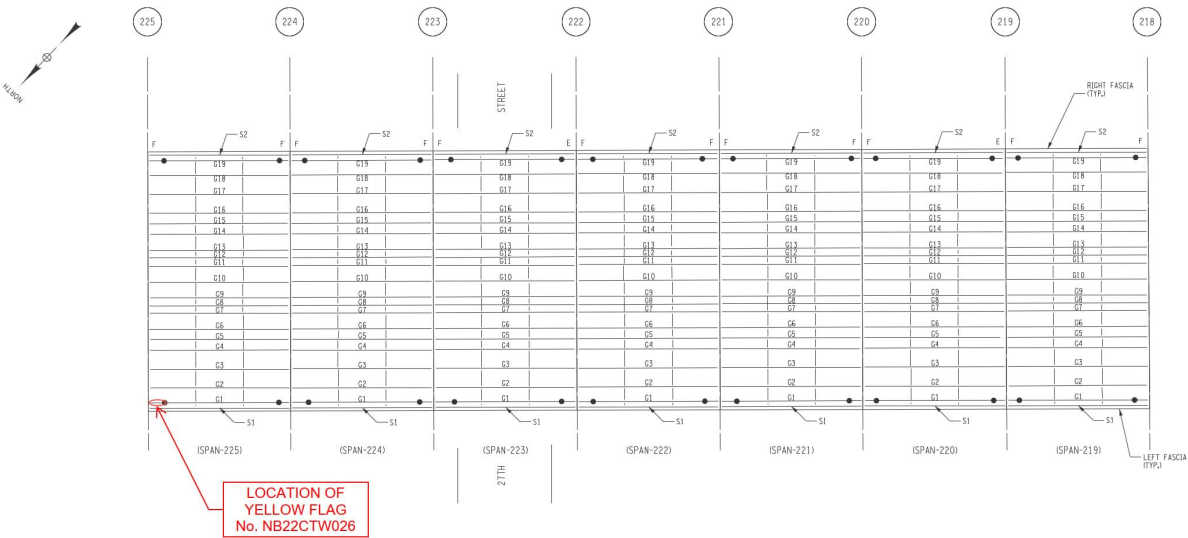
Photo Number: 1

Attachment Description: Framing Plan Span 225

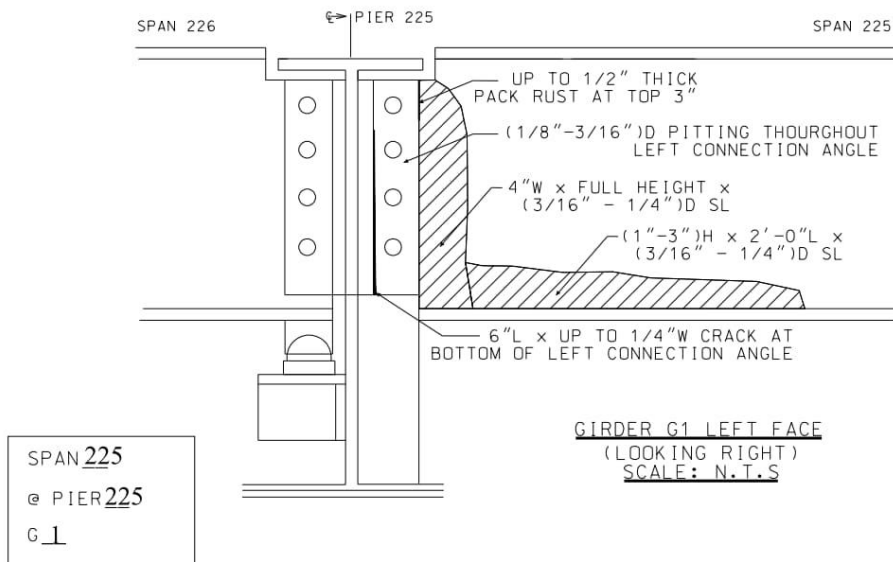
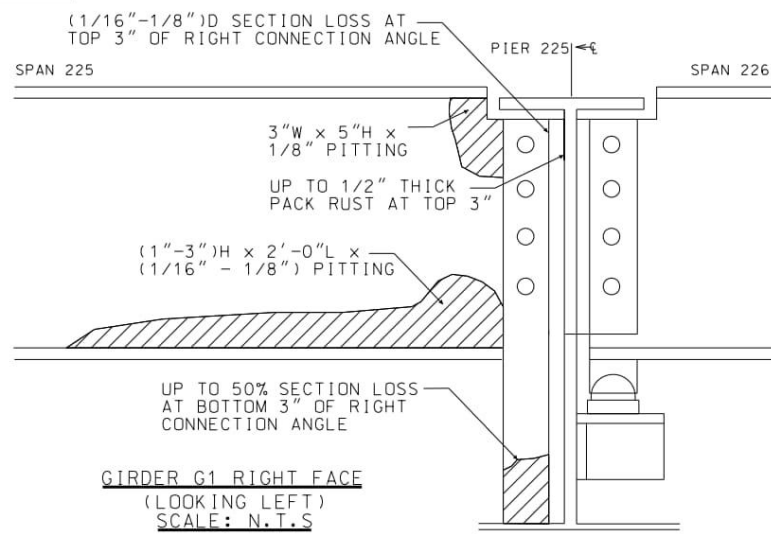
Photo Number: 2

- 3.The web at G1, along the connection angle, exhibits approximately 36% overall section loss for 4" wide over the full height $(0.1875" + 0.25")/2 = 0.219"$; $0.219"/0.608" = 0.36$ (36%). Additionally, the lower web on the left side exhibits a 1" to 3" high by 2'-0" long area with 3/16" to 1/4" deep section loss. The right side of Girder G1 web exhibits a 5" high by 3" wide area with 1/8" deep pitting at the top cope. The lower web exhibits a 1" to 3" high by 2'-0" long area with 1/16" to 1/8" deep pitting (see sketch).

Attachment Description: Yellow Flag Condition Sketch

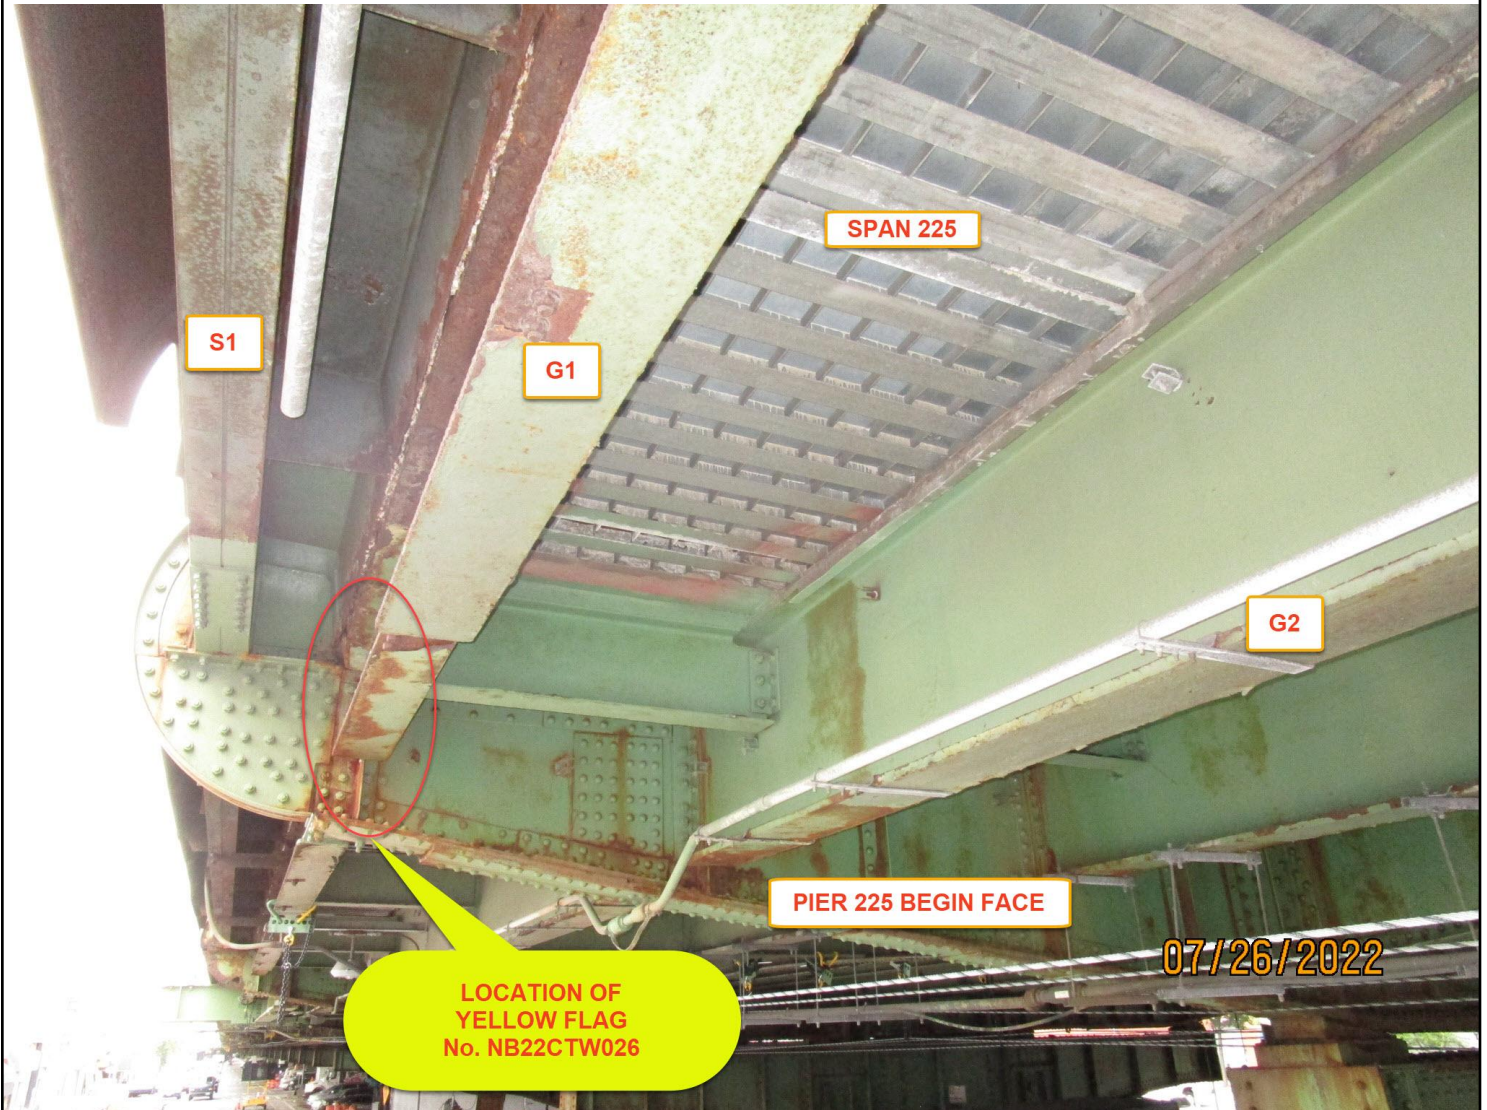
Photo Number: 3

Description: The left side connection angle of Girder G1 in Span 225 at Pier 225 exhibits a 6" long by up to 1/4" wide corrosion crack in the fillet of the connection angle. Additionally, the connection angle exhibits up to 1/2" thick pack rust at the top 3 inches and 1/8" to 3/16" deep pitting throughout.

Attachment Description: General view of the flagged condition at Span 225 Girder G1 at Pier 225. Looking End.

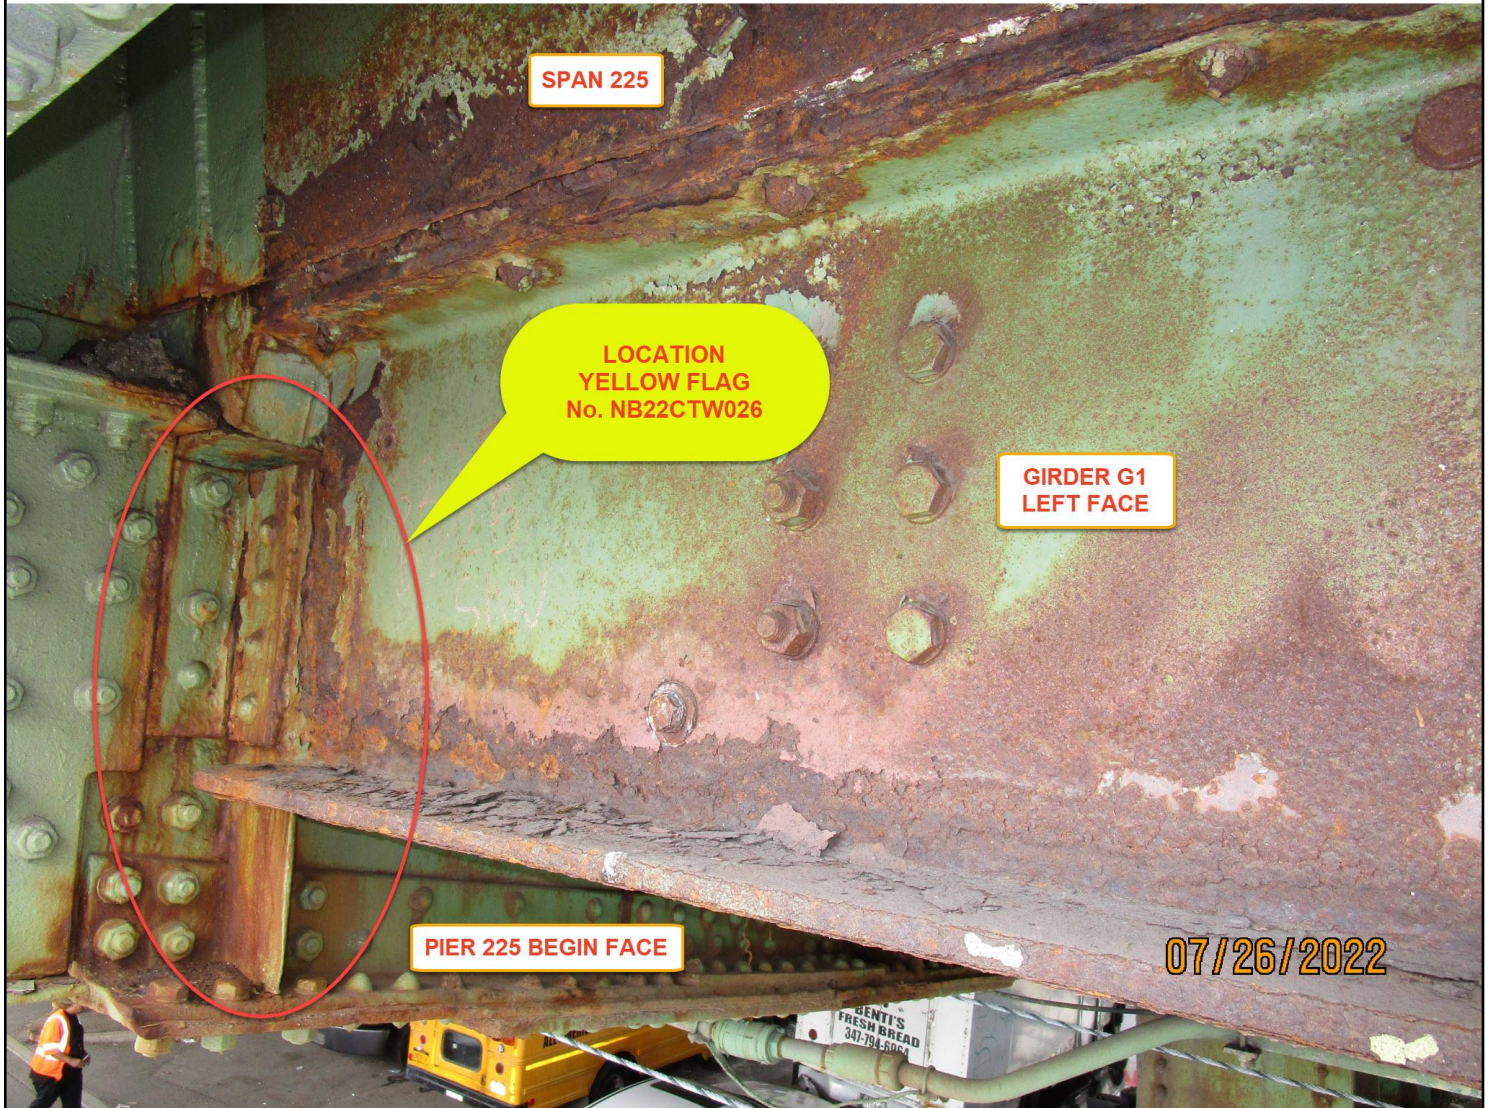
Photo Number: 4

Attachment Description: Close up general view of the flagged condition at Span 225 Girder G1 at Pier 225. Looking End Right.

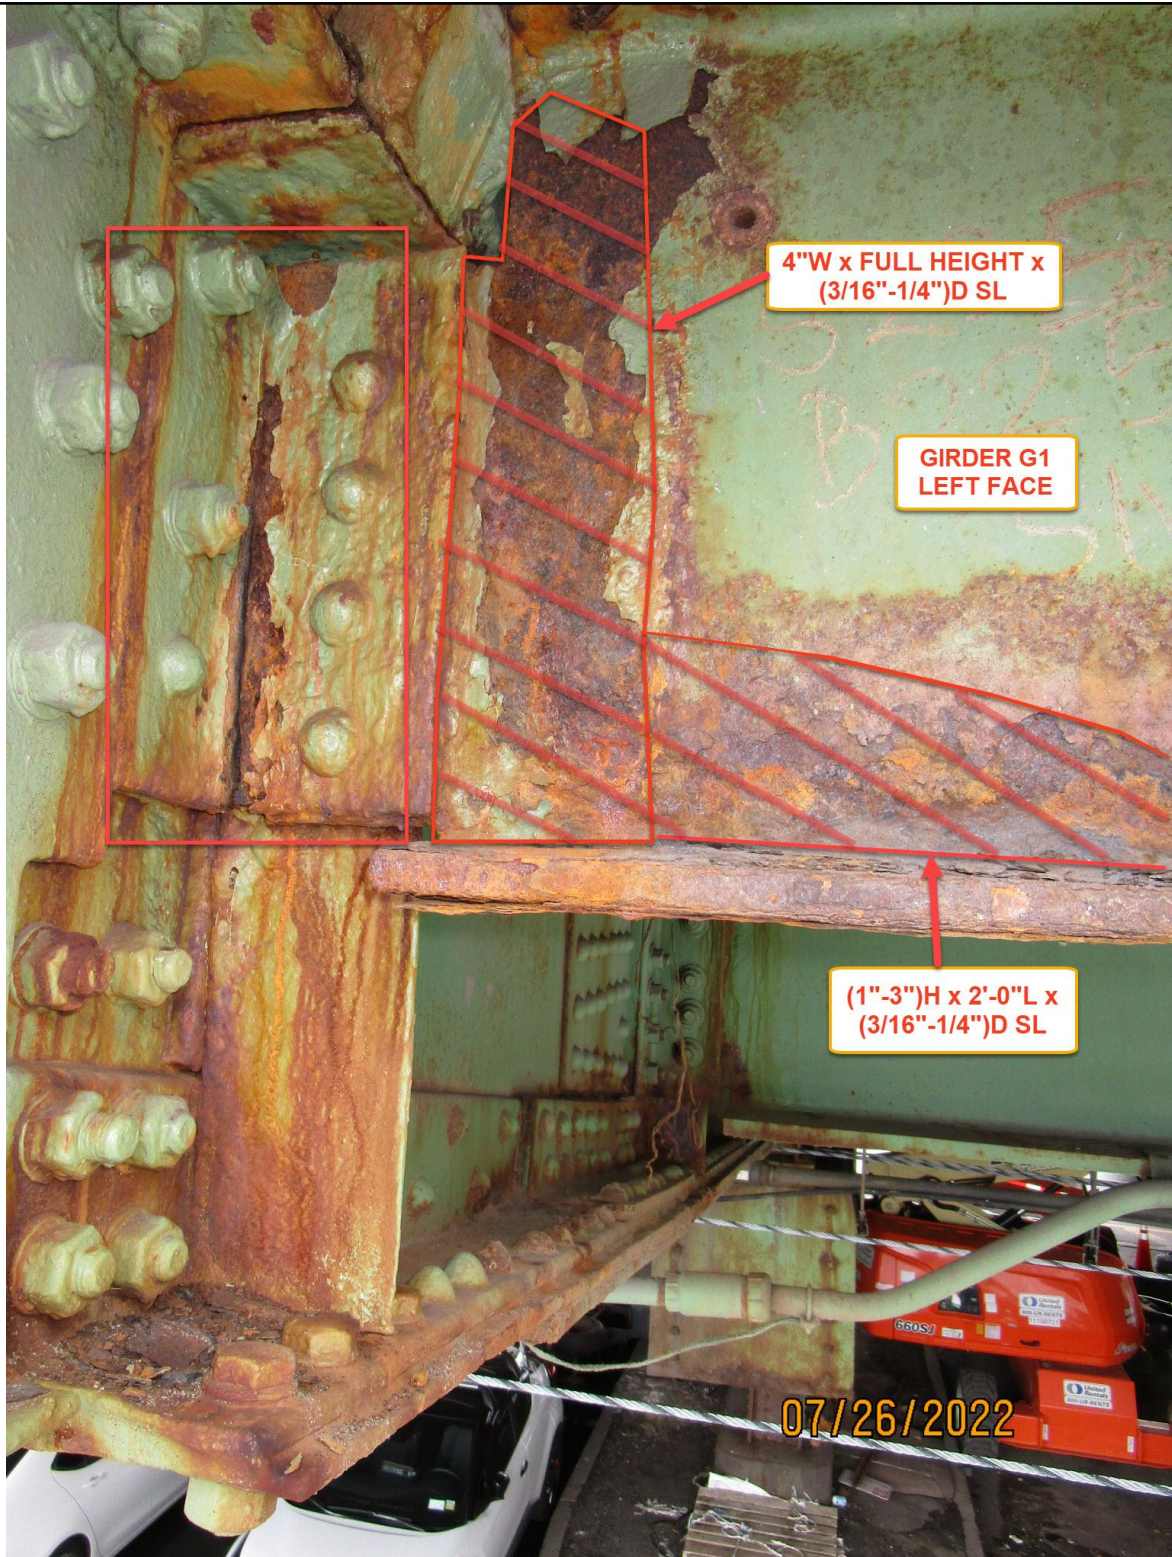
Photo Number: 5

Attachment Description: The left side connection angle at Girder G1 in Span 225 exhibits a 6" long x up to 1/4" wide corrosion crack in the fillet of the connection angle. Looking Right.

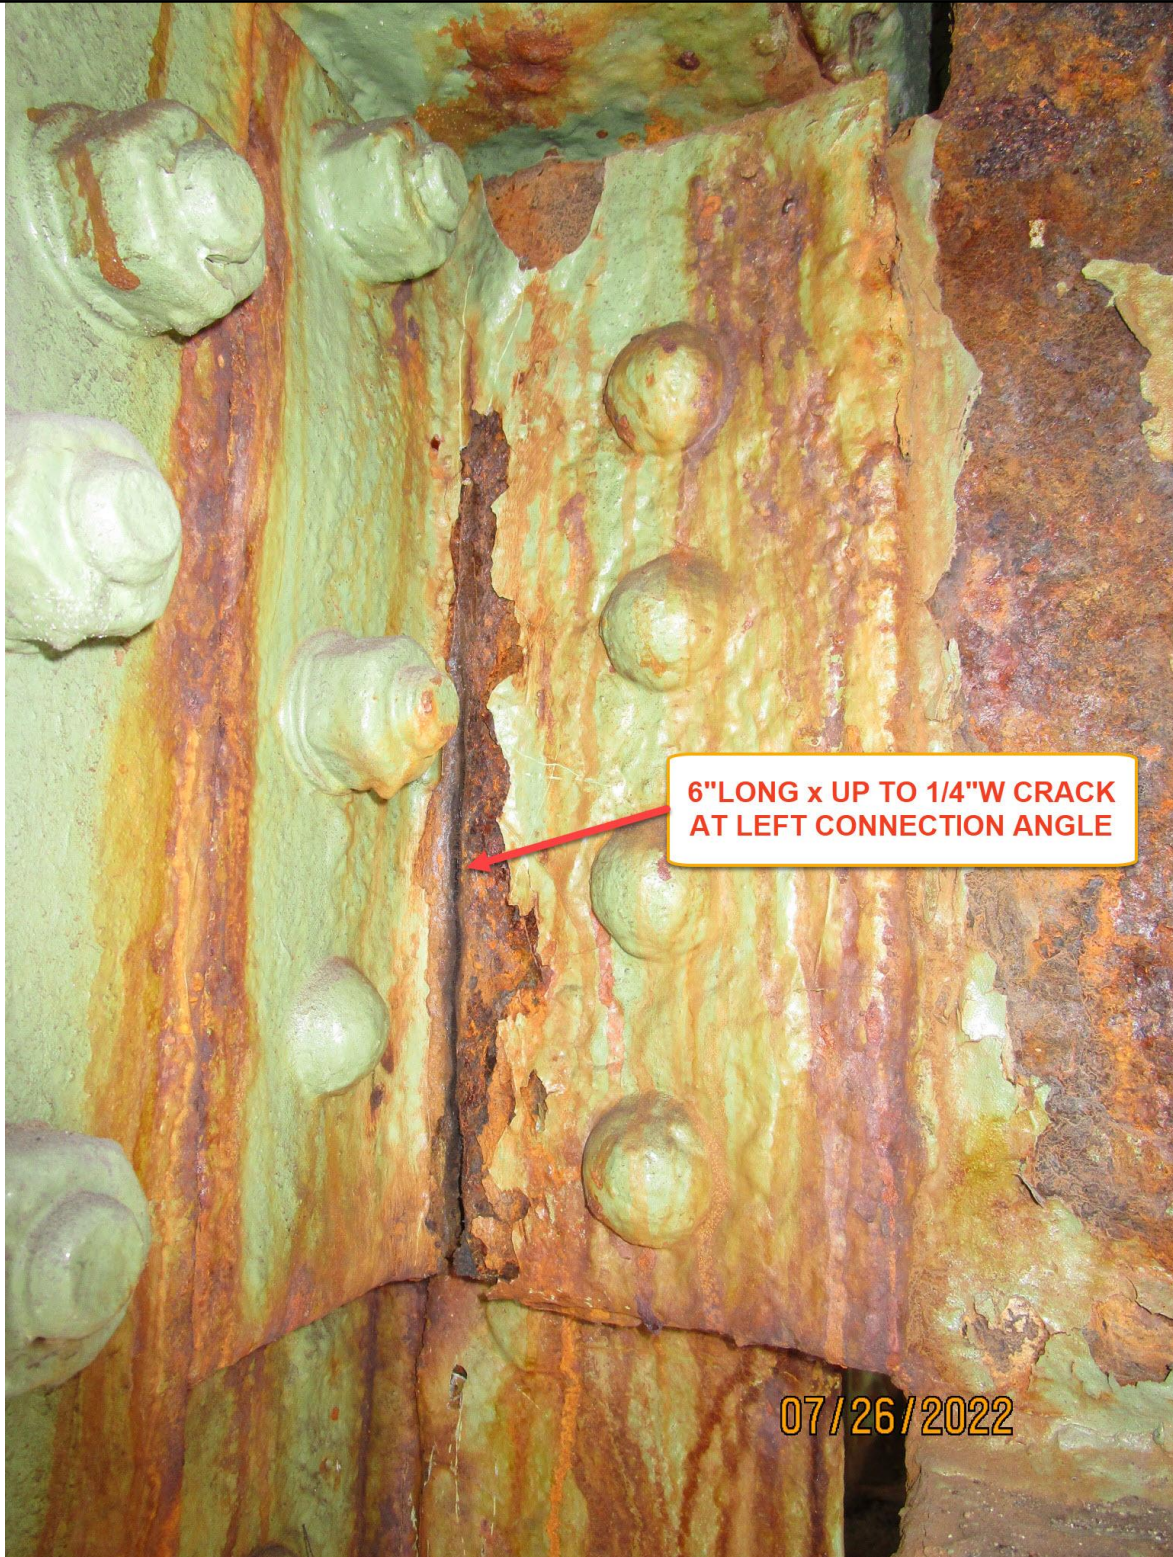
Photo Number: 6

Attachment Description: Close up view of the left side connection angle with a 6" long x up to 1/4" wide corrosion crack in the fillet of the connection angle. Looking Right.

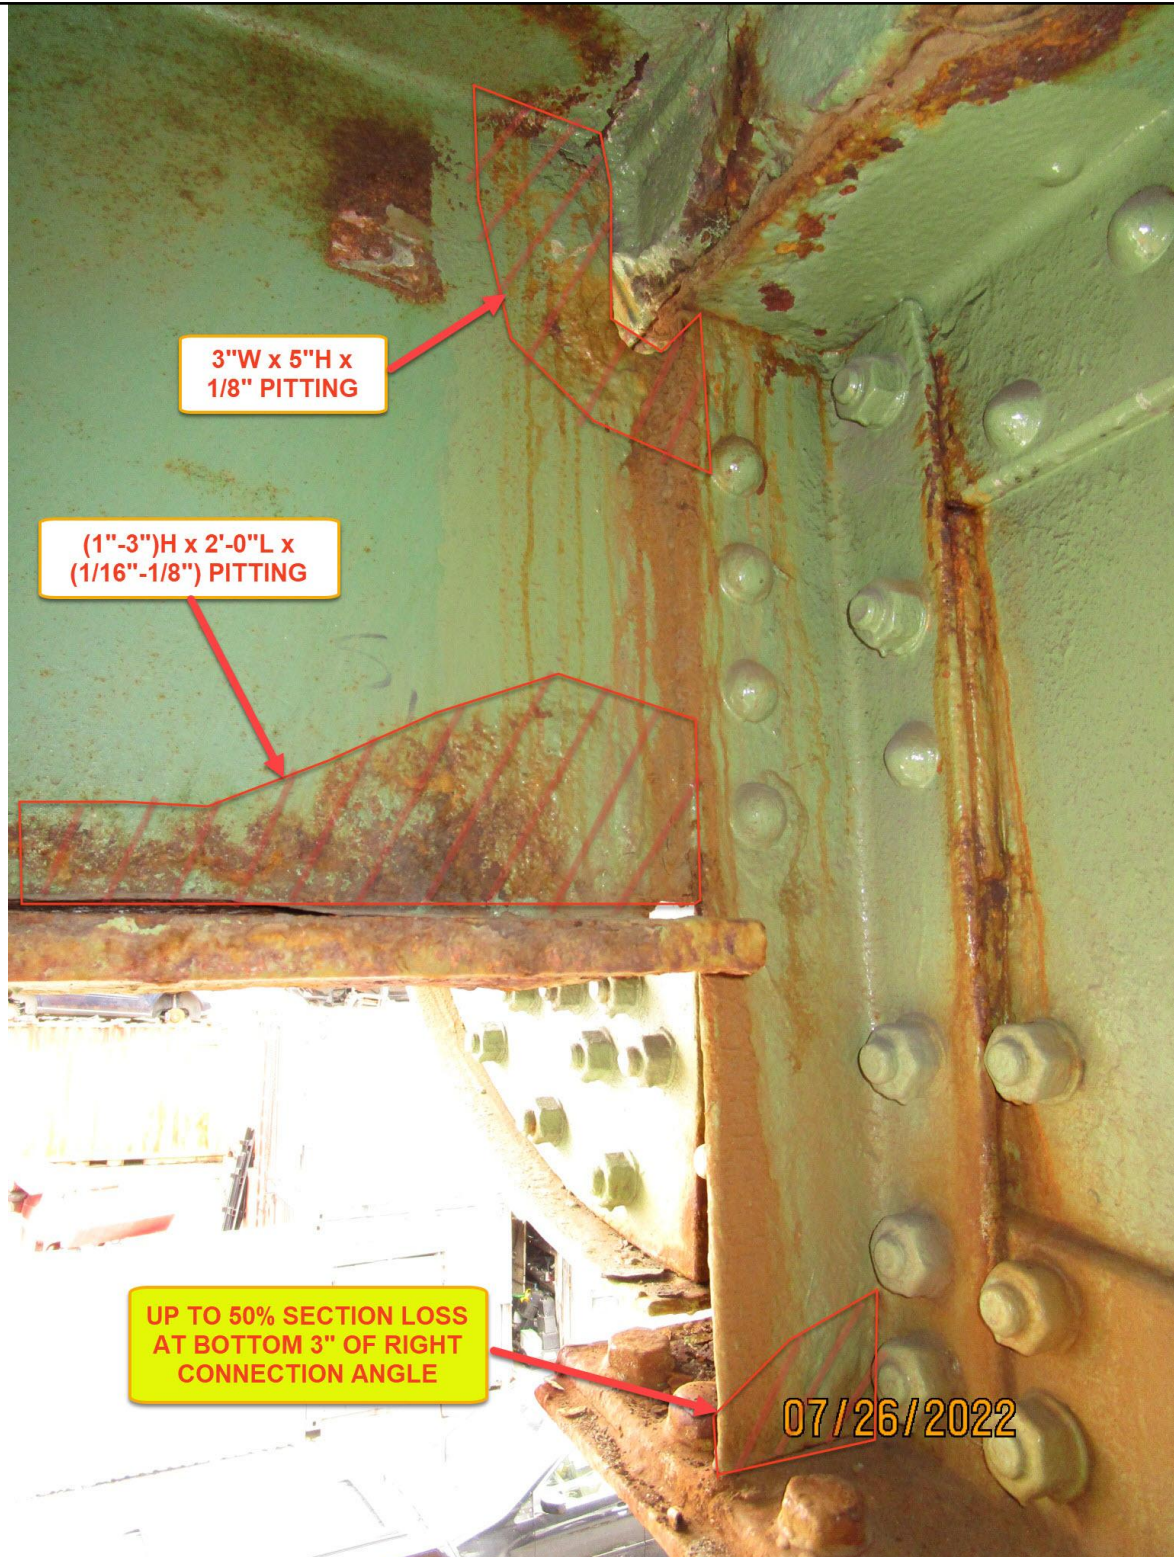
Photo Number: 7

- 1.The affected member, Girder G1 is load path redundant steel girder.
- 2.The right side connection angle of G1 at Pier 225 exhibits up to 1/2" thick pack rust at the top 3 inches, and the bottom 3 inches exhibit up to 50% section loss.

Attachment Description: The right side connection angle at Girder G1 in Span 225 exhibits up to 1/2" thick pack rust at the top 3 inches, and the bottom 3 inches exhibit up to 50% section loss. Looking Left.
